# Fire Protection Root Cause Analysis

**AFFF Unwanted System Discharge  
Hangar 4  
Midcoast Regional Redevelopment  
Authority (MRRA)**

**October 1, 2025**

**Poole Fire Protection**  
19910 West 161<sup>st</sup> Street  
Olathe, Kansas 66062  
[www.poolefire.com](http://www.poolefire.com)

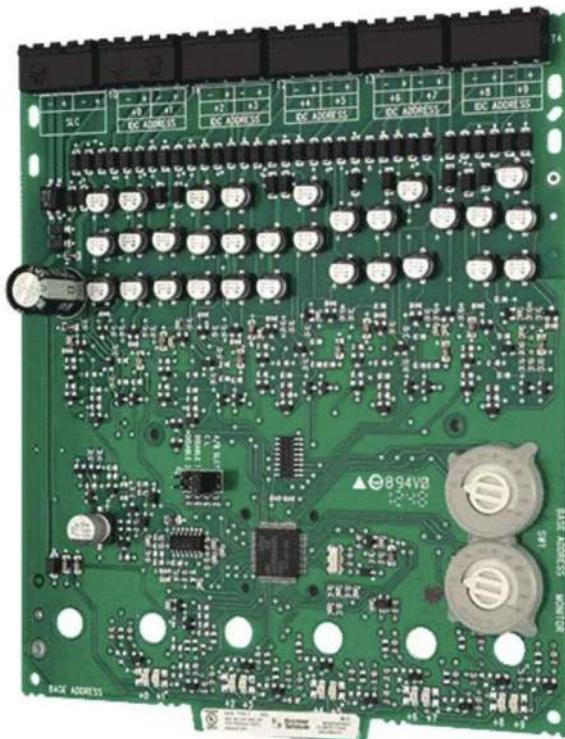
**Notifier XP10-M, Ten Input Monitor Module/Card**

Neither the internal components of Module 22, nor the module itself were examined in detail. Such an exercise (examining precisely how a particular piece of equipment failed at a granular level) would require outside testing that is beyond the scope of our expertise, but is not essential to our conclusion regarding the piece of equipment that we believe failed and is the source of the unwanted discharge, as explained herein. However, based on testing that was conducted at the site after the incident, the waterflow and pressure switches being supervised by the Module 22 operated correctly and Module 22 activated which initiated Zones/Relay 91, 92 and 93 as programmed (i.e., it did what it was supposed to do based on a signal it received). The Notifier XP10-M, Ten Input Monitor Module/Card or Module 22, which is part of the XP10-M, Ten Input Monitor Module/Card had an intermittent or unknown internal fault causing activation or improperly triggering a module response. **As detailed below, the most likely reason the module was activated, and thus triggered Zones/Relays 91, 92, and 93, was not due to an activation of a waterflow or pressure switch but, instead, is likely due to a fault in a card of which Modules 22 was a part: the Notifier XP10-M, Ten Input Monitor Module/Card.**

*The vane-type waterflow switches and the pressure actuated switches are of a mechanical-electrical type of switch. These mechanical-electrical type of switches are considered less likely to have an unwanted or intermittent alarm than those of the Module/Card. This module card, pictured below, has many*

*electronic components and even computer chips, any one of which could have caused an unwanted or intermittent alarm signal to be created, initiating Module 22. It is my opinion; that, if a more granular understanding is desired as to what electronic component or chip in that module failed, then the Notifier XP10-M, Ten Input Monitor Module/Card should be evaluated further, including an inquiry into whether this model or batch of modules/cards has had past issues with intermittent or unwanted actuations, and/or to perform further electronic testing of the specific card currently installed.*
