Mare Brook Impairment & Stressors

Kristin Feindel, Biologist
Division of Environmental Assessment

MAINE DEPARTMENT OF ENVIRONMENTAL PROTECTION

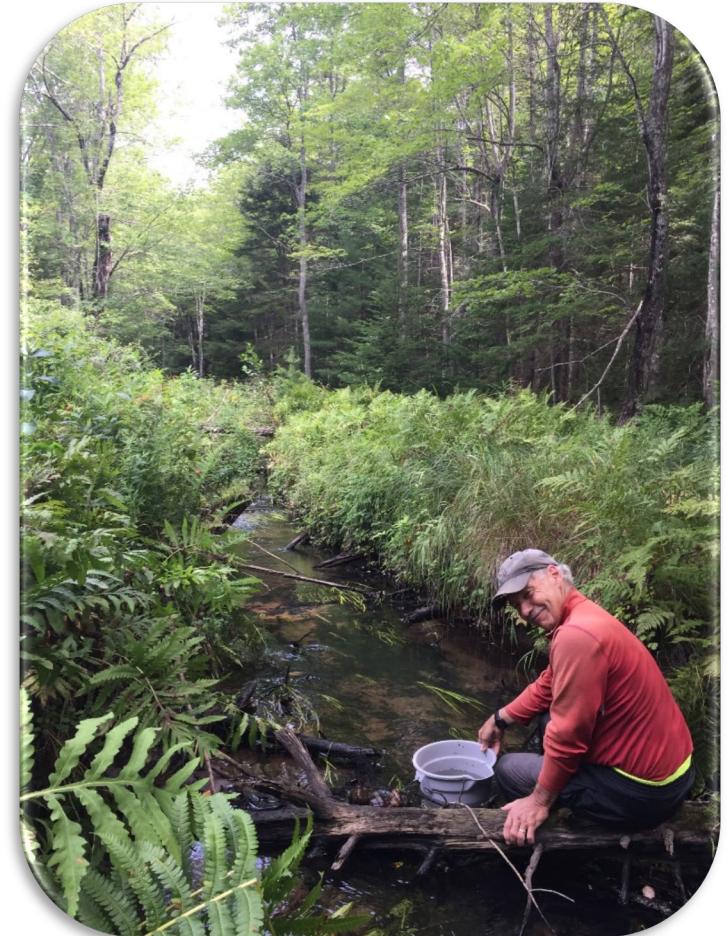
Aquatic life assessed with macroinvertebrate rock bags

- Place bags of rocks in stream in summer
- Leave for 4 weeks
- Retrieve bags and rub bugs into collection jars
- Bugs are picked out at lab
- Sent away for species analysis

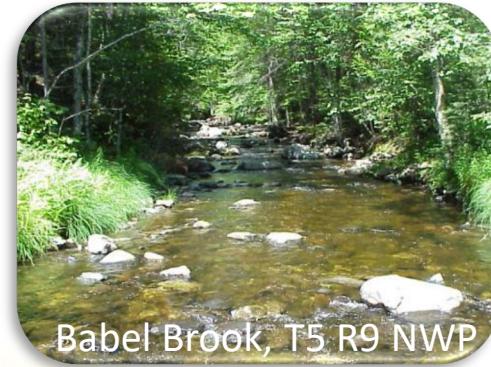
Class A Stream

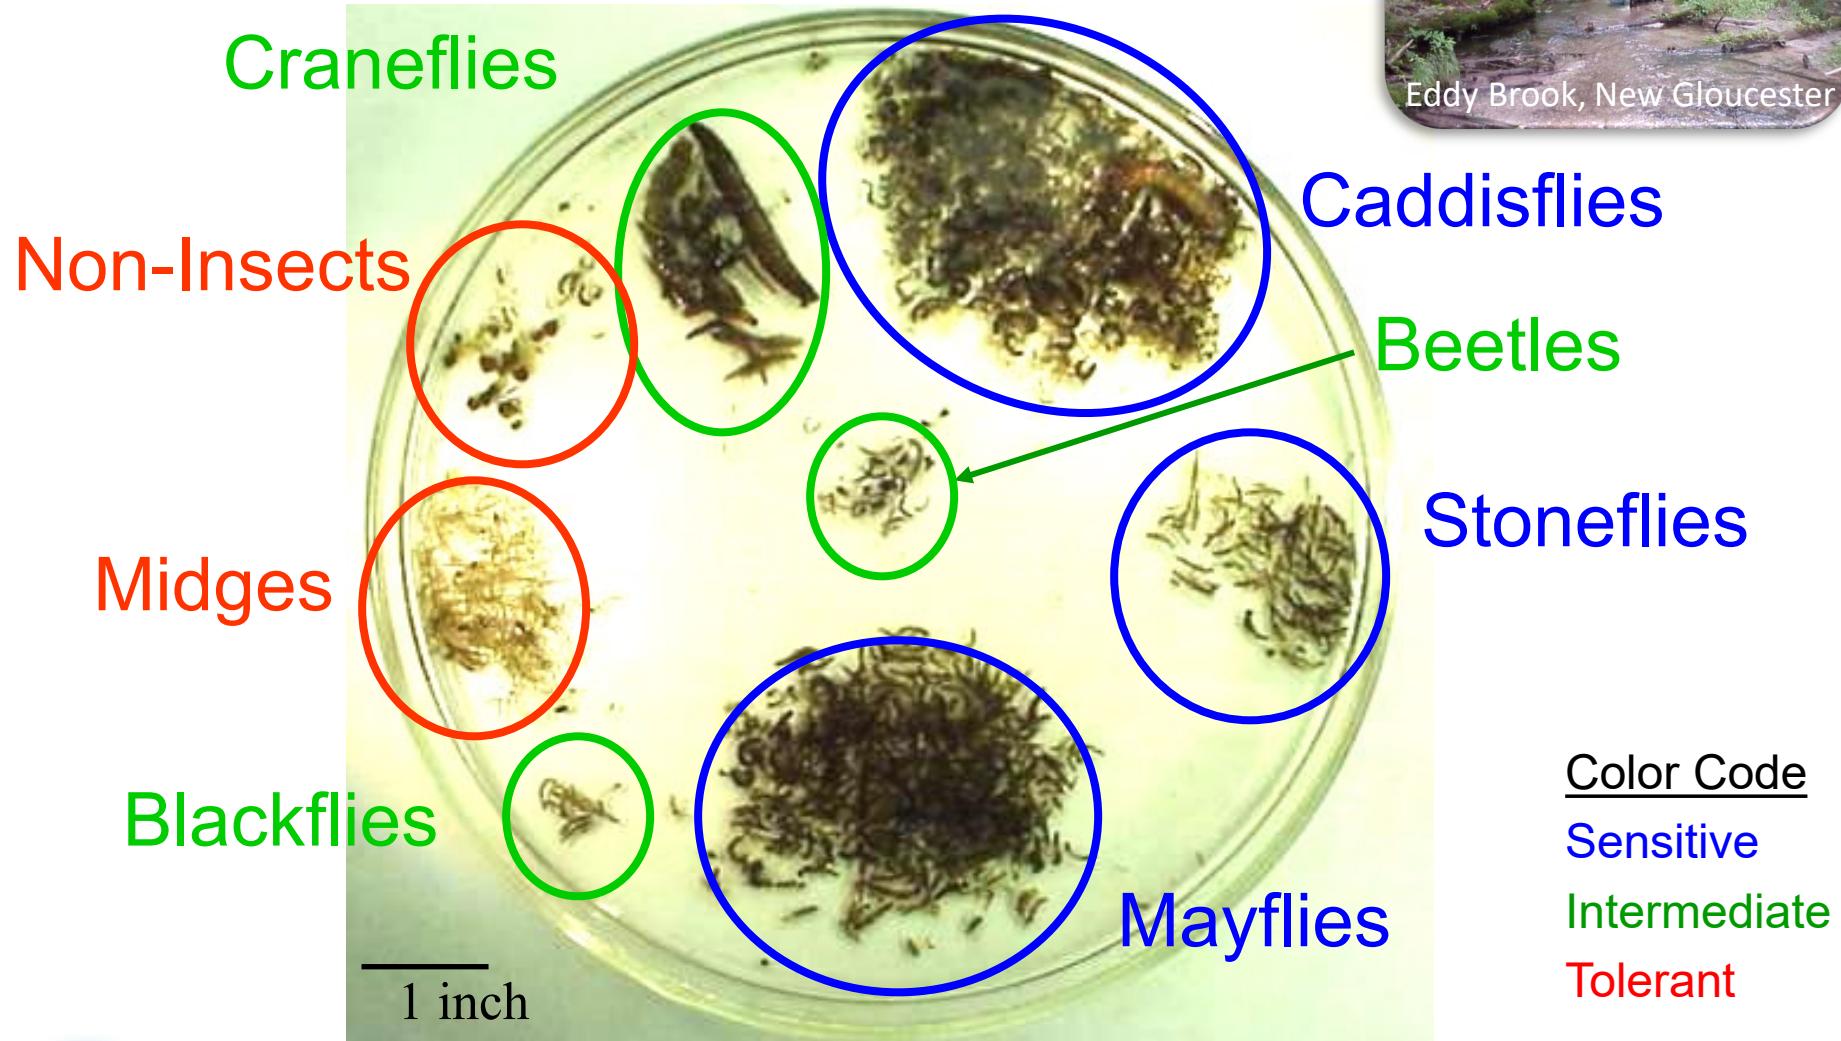
Class B Stream

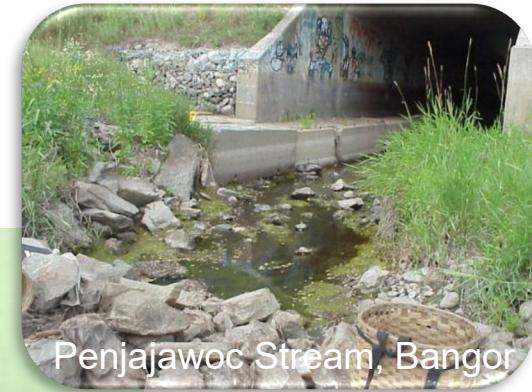
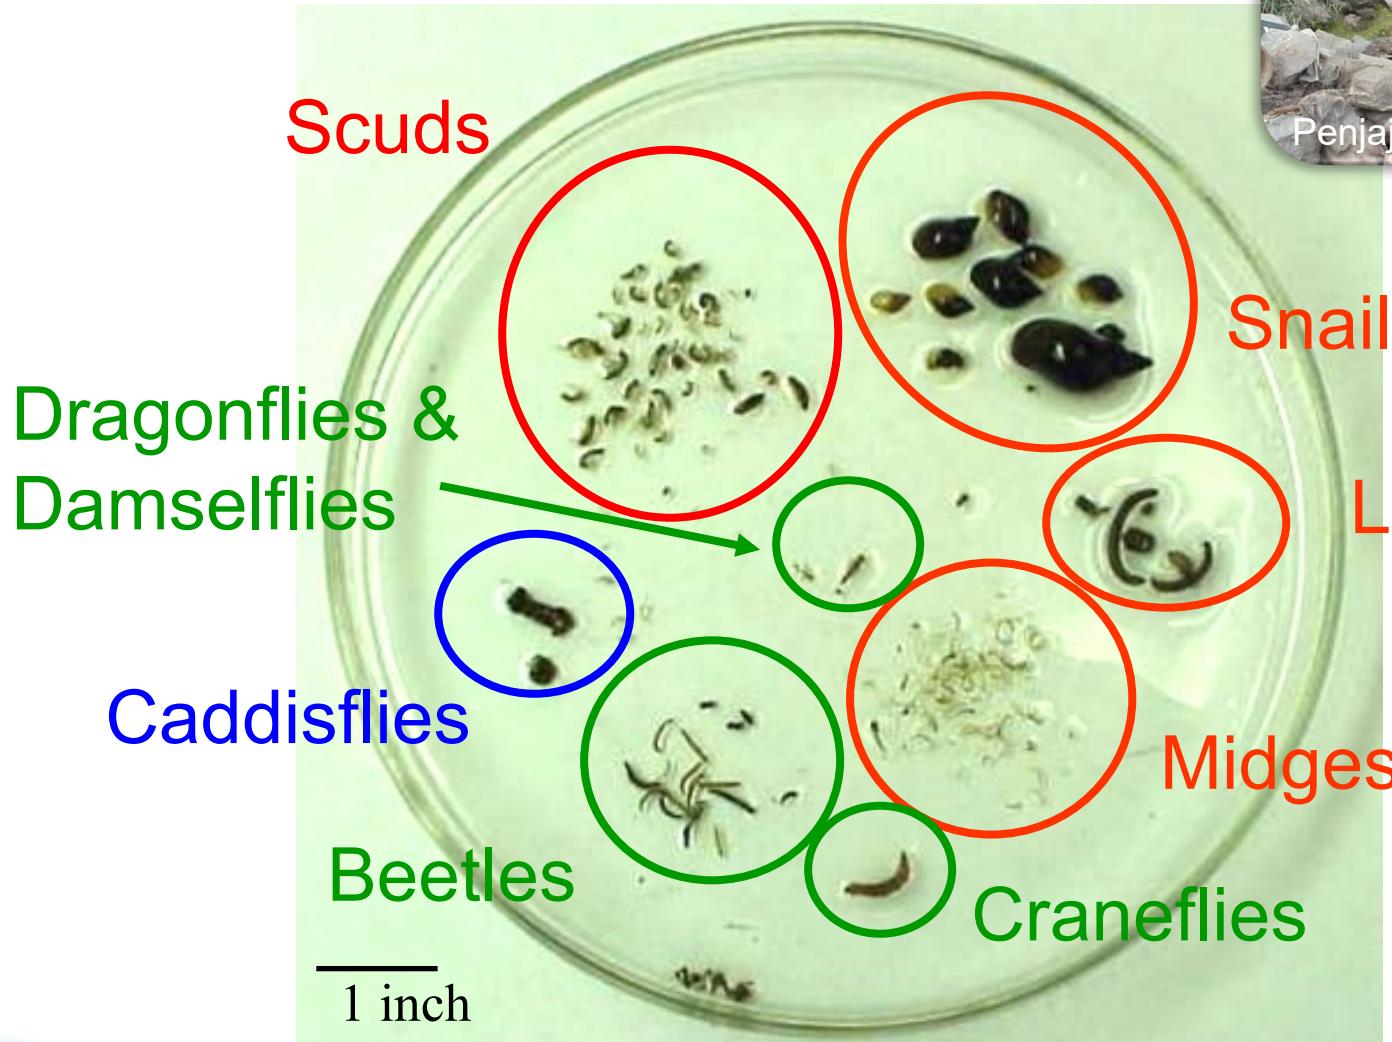
Non-Attainment Stream

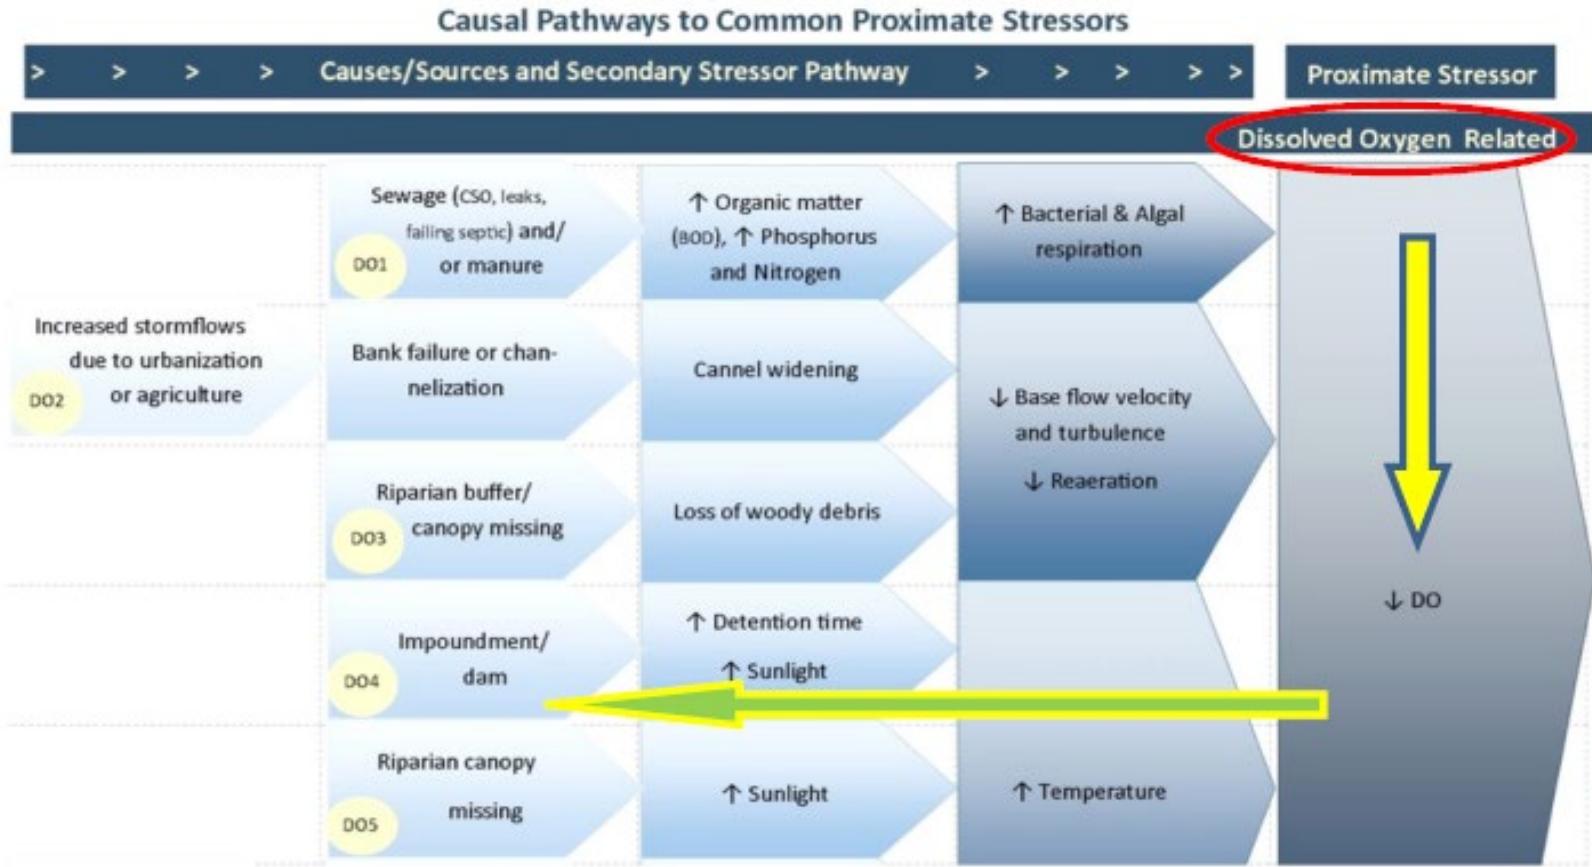
DEP & Technical Advisory Committee determined causal pathways

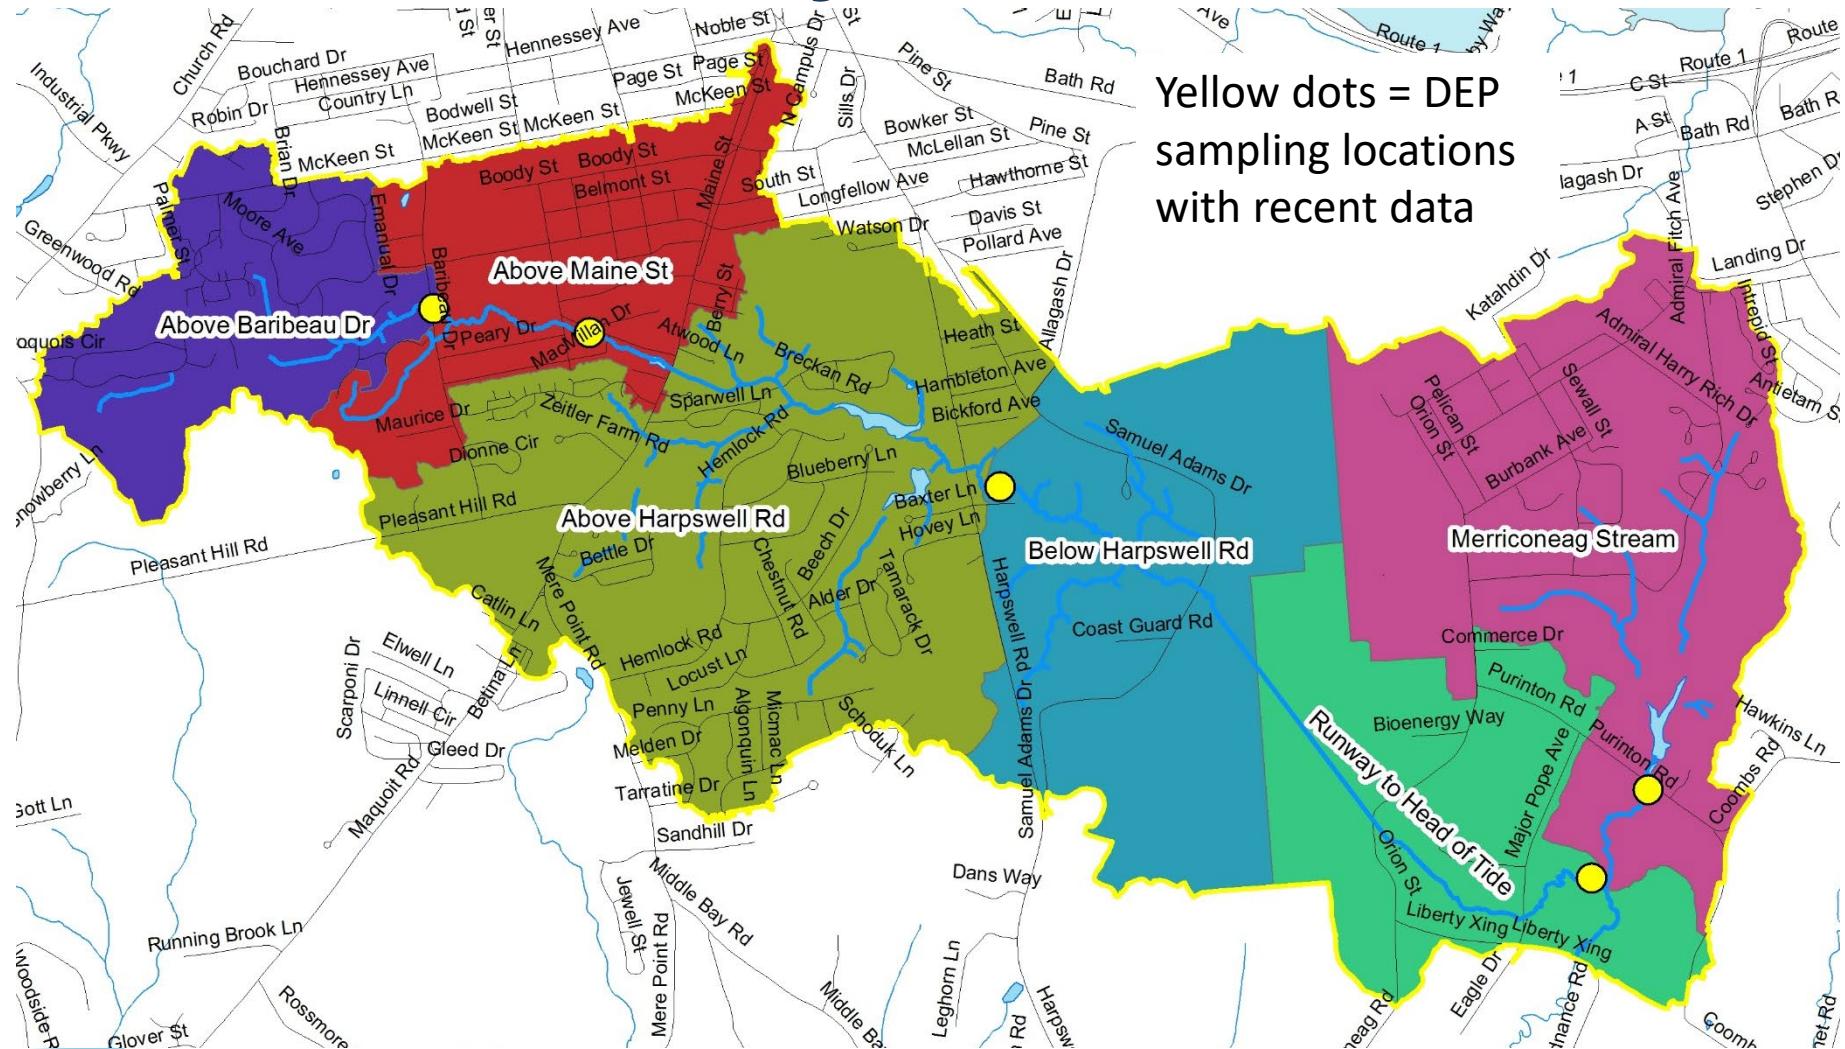
Mare Brook stressor analysis was conducted by stream sections

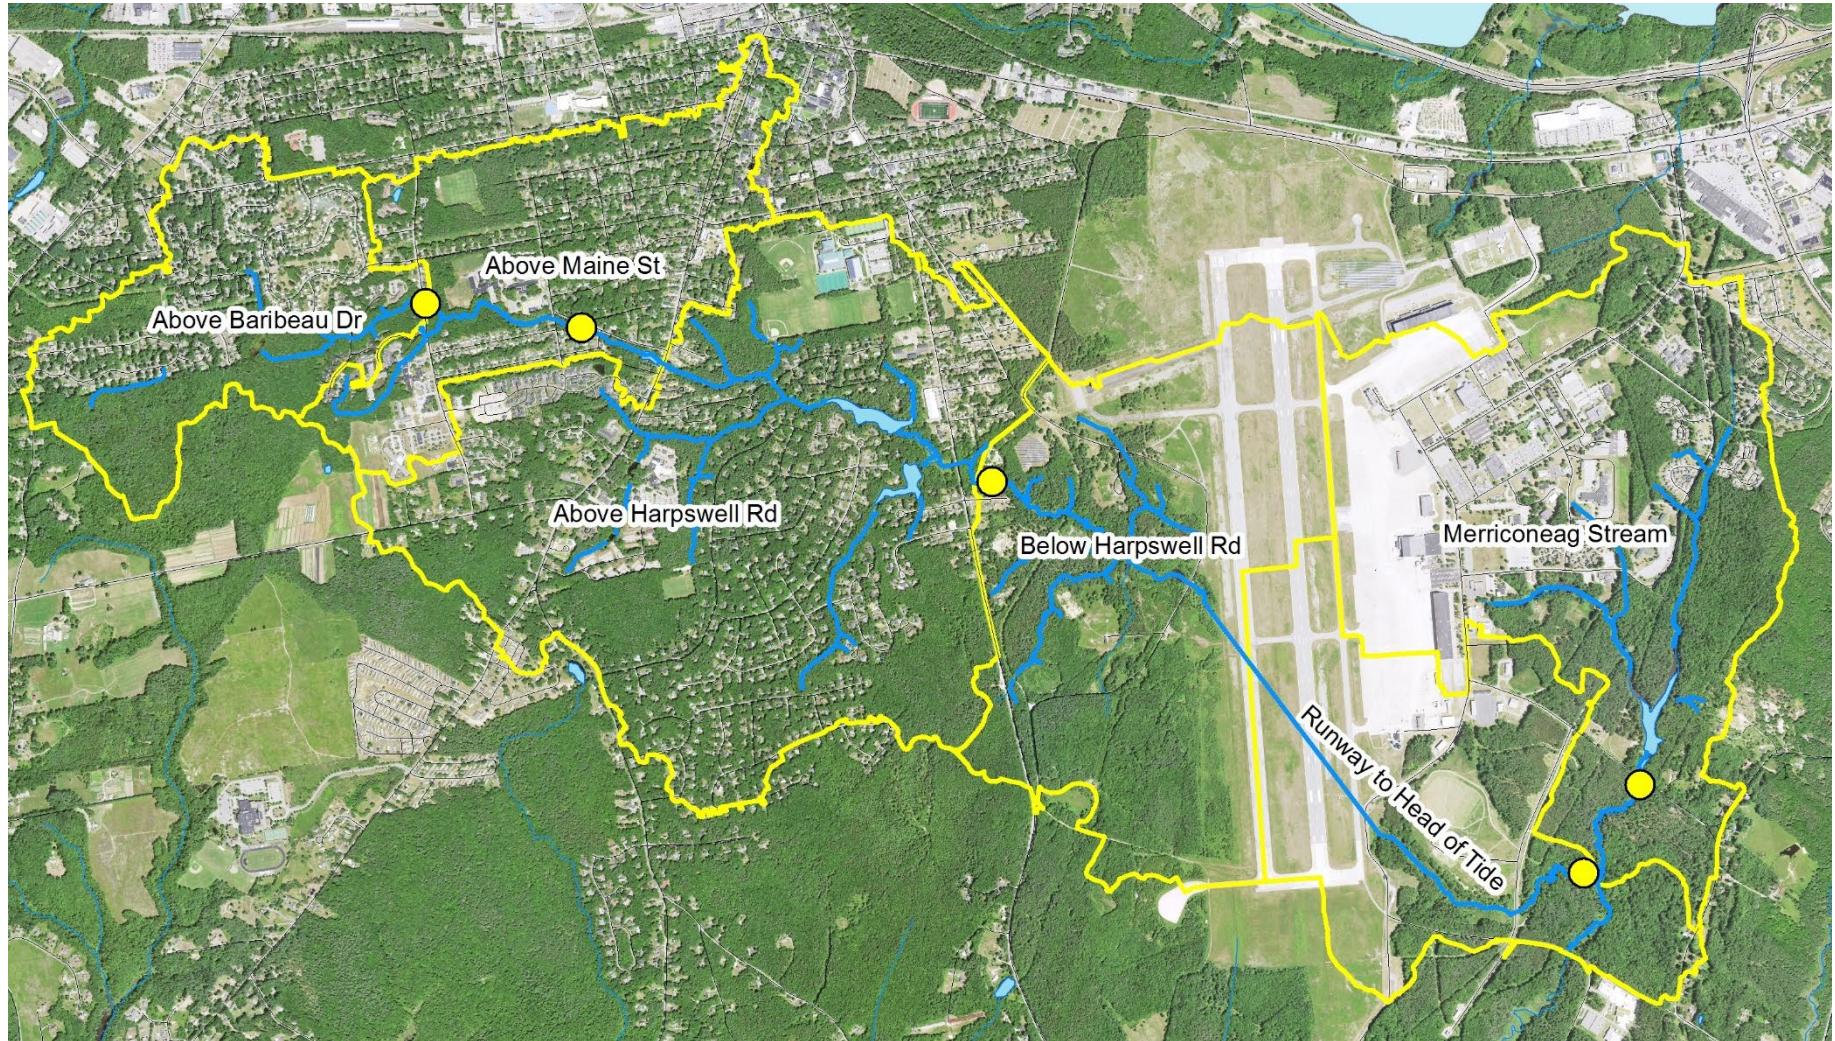
Mare Brook stressor analysis was conducted by stream sections

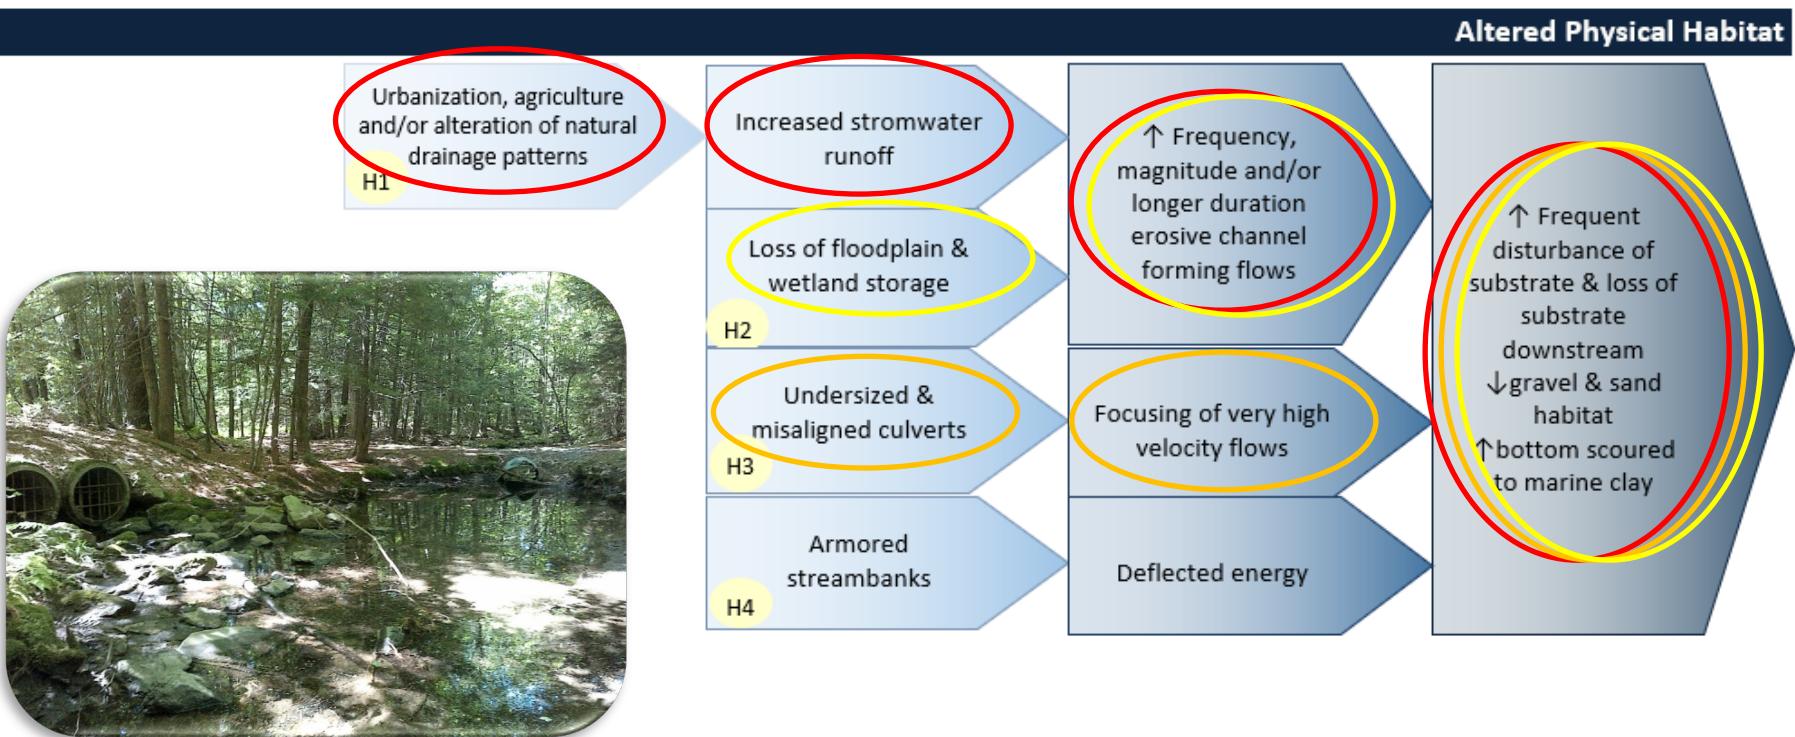
Primary Stressor for all Sections was Altered Physical Habitat

> > > > Causes/Sources and Secondary Stressor Pathway > > > > > Proximate Stressor

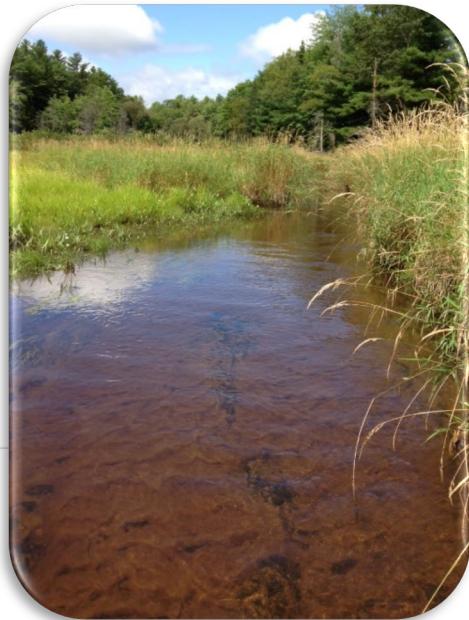
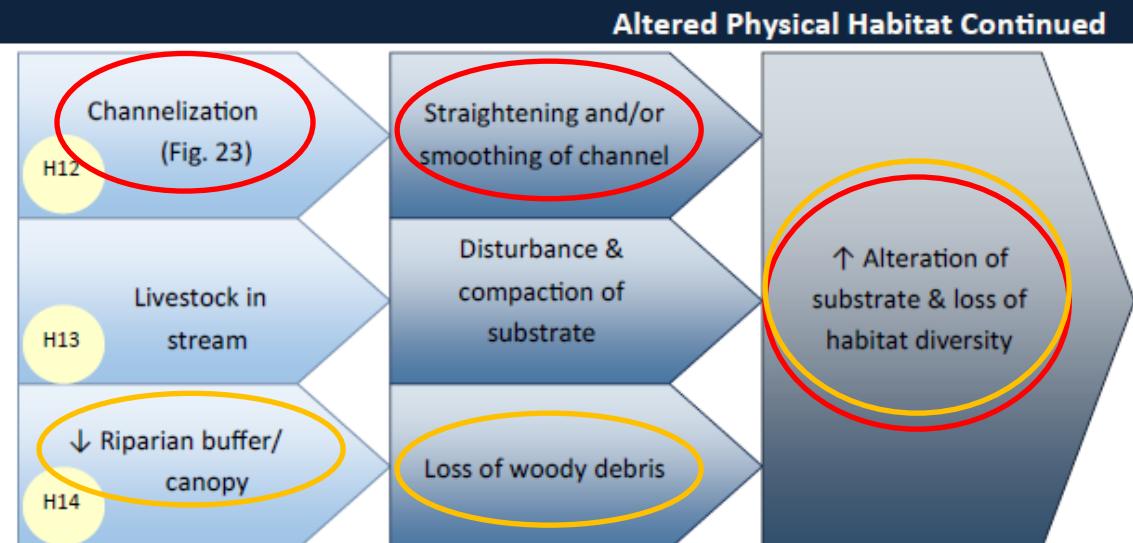
Primary Stressor for all Sections was Altered Physical Habitat

> > > > Causes/Sources and Secondary Stressor Pathway > > > > > Proximate Stressor

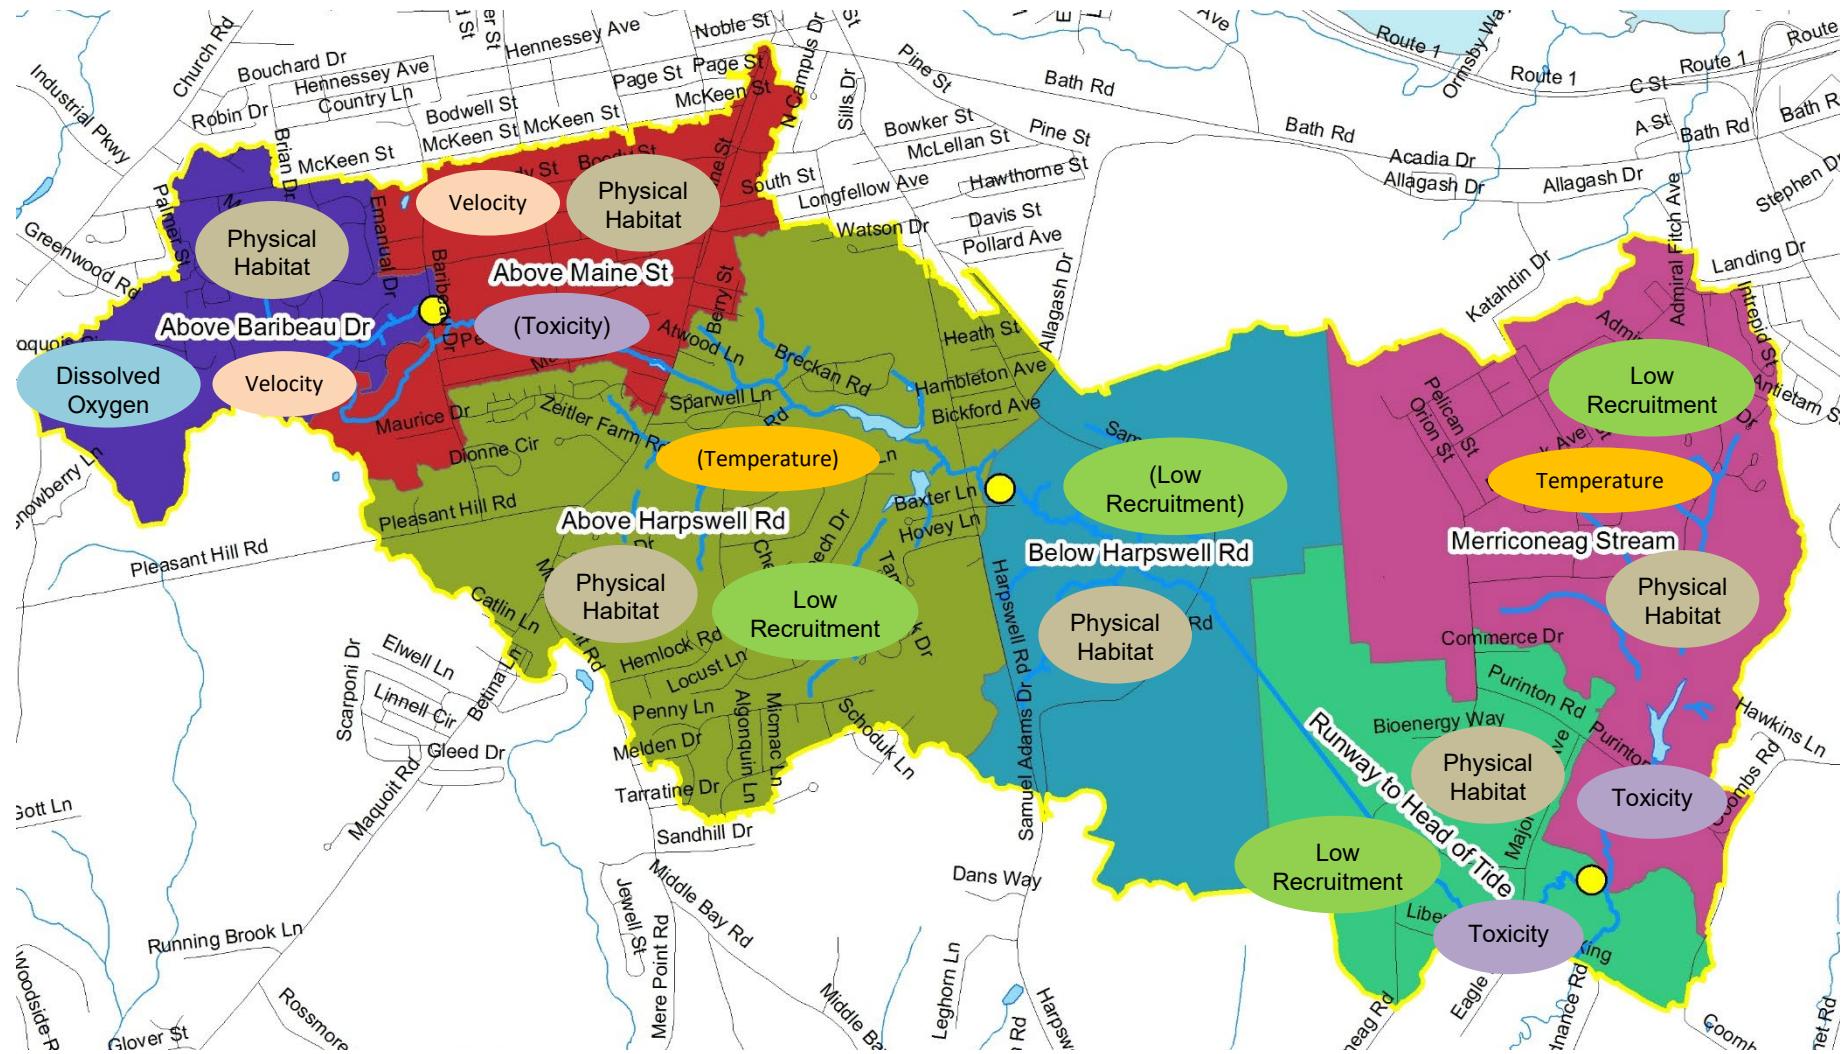
Stressors by Stream Section

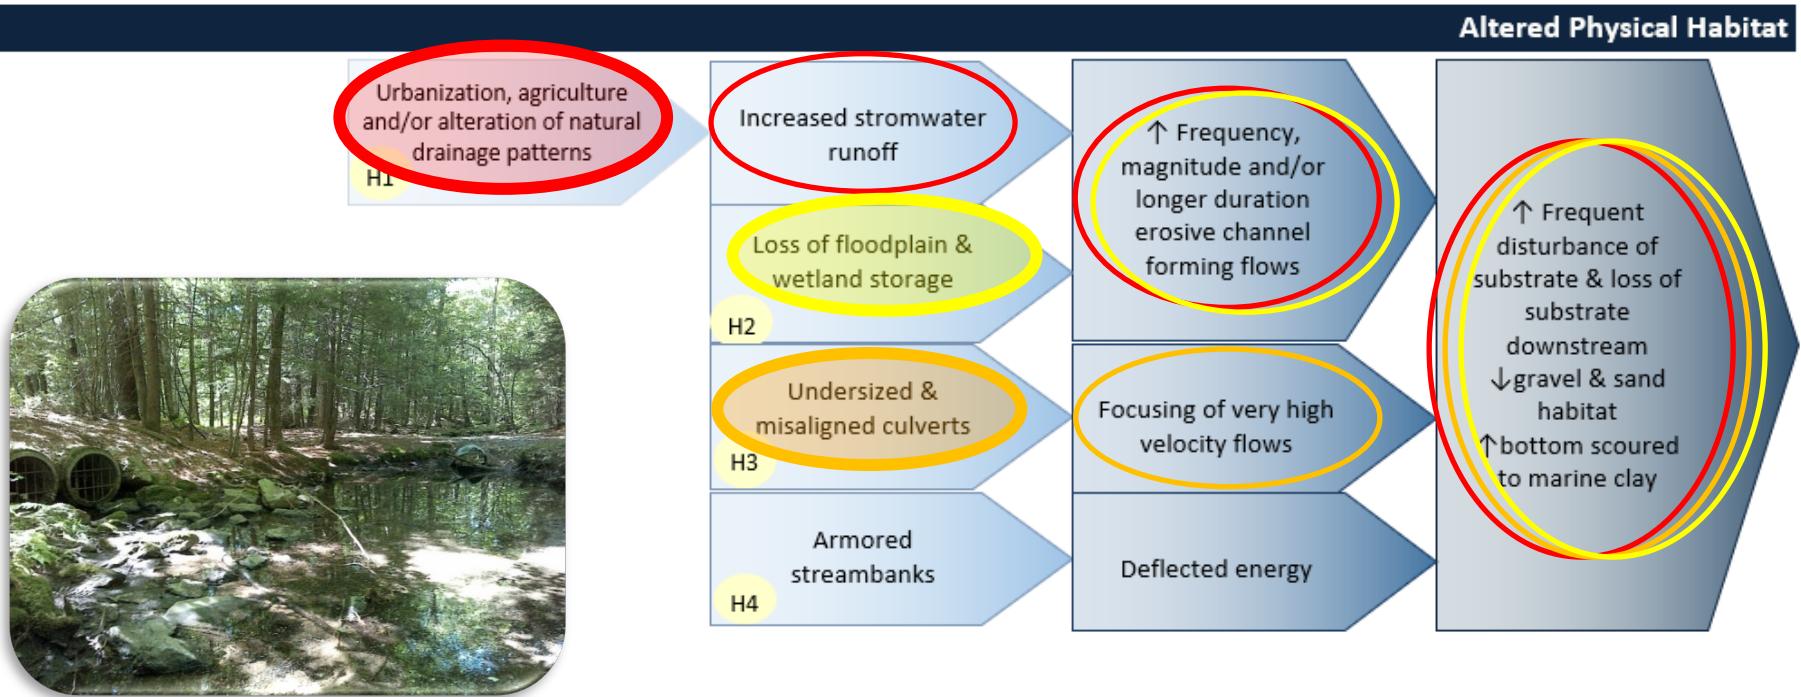
Determine Cause/Source of Stressor

> > > Causes/Sources and Secondary Stressor Pathway > > > > > Proximate Stressor
